This fact sheet provides a summary of the key findings of the initial building characterization study of the 130 Liberty Street building, released on September 14, 2004. This study was commissioned by the Lower Manhattan Development Corporation in anticipation of the upcoming cleaning and deconstruction of the building.

As a first step in the development of the detailed cleaning and deconstruction plan, LMDC commissioned the Louis Berger Group, Inc. (Berger) to conduct an independent, initial building characterization study. On September 14, 2004, LMDC released the Berger report, *Initial Building Characterization Study Report - VOLUME I and II*.

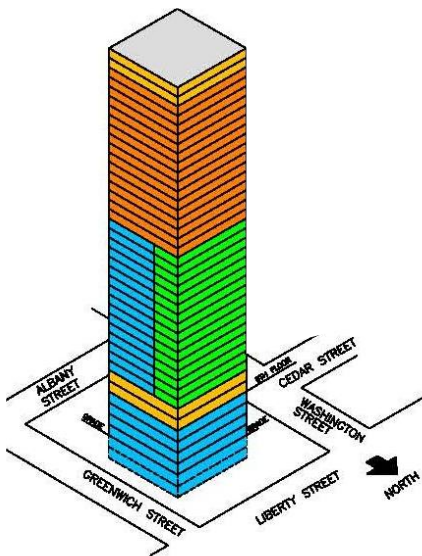
Figure 1 Building Zones

For this task, an initial site survey was conducted to establish sampling zones. Six general sampling zones were identified (see Figure 1 and Table 1 below). The sampling zones were established based on the amount of visible dust present and the means by which dust, fumes, and debris entered into or originated in the building during and after the events of September 11th. Dust, fumes, and debris may have entered or originated in the following ways:

Zone	Description	Number of Sample Locations
1	Mechanical Rooms on the 5th, 6th, 40th, and 41st Floors to include the air intakes, fan rooms, and air handling units of the HVAC system.	32
2	Office Space located at or below the 24th Floor.	39
3	Office Space located above the 24th.	38
4	Gash Area that was cleaned by Deutsche Bank subsequent to September 11, 2001 to permit structural work to be performed.	9
5	Roof Area.	4
6	Exterior façade.	3
